Oroville FERC Relicensing (Project No. 2100)

SP-F3.1 Task 1A Final Report

**Assessment of Fish Passage
Impediments Above Lake Oroville's
High Water Mark**

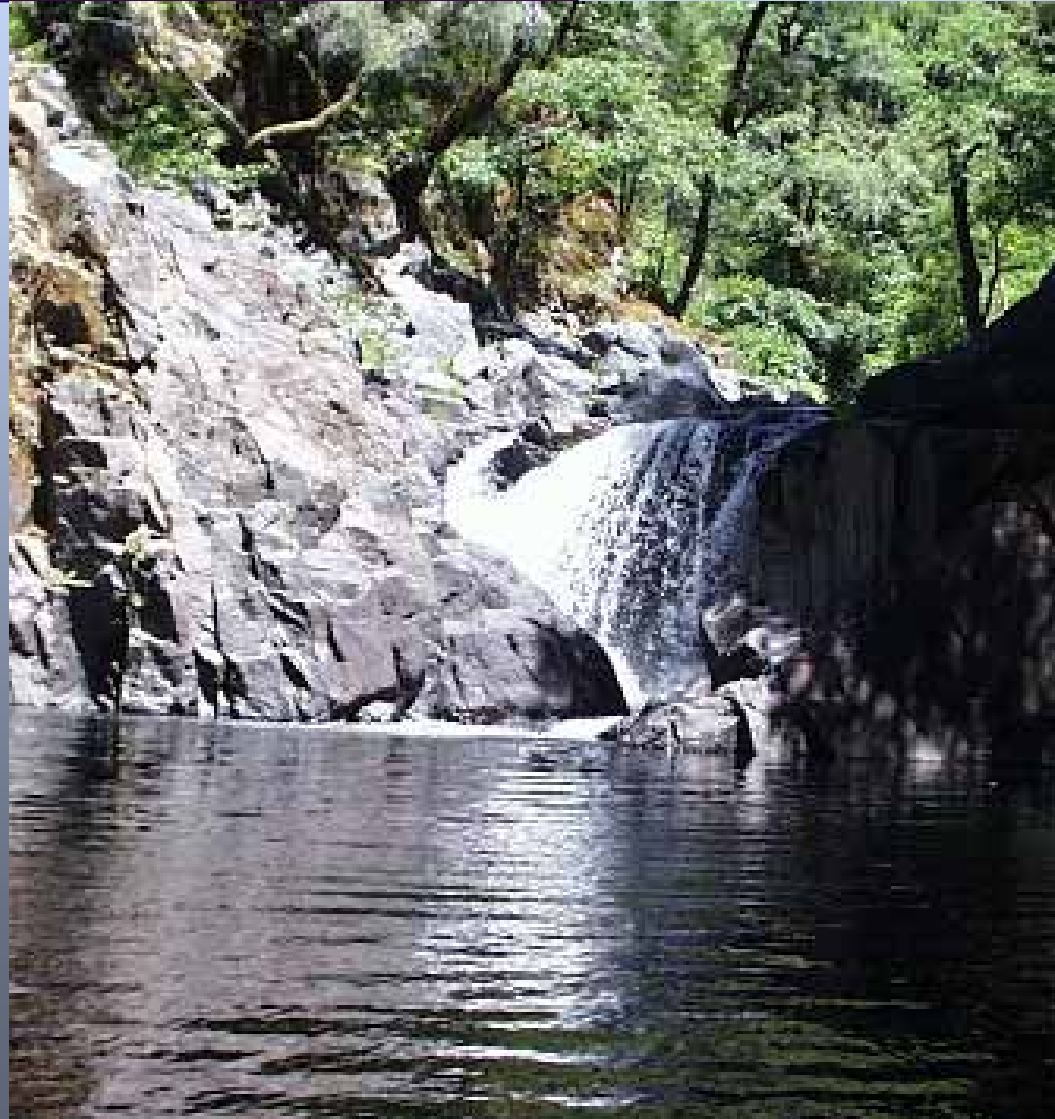
Falls Below Big Kimsheew Creek

- ◆ Height approx. 16 to 19 feet
- ◆ Pool is 16 to 23 feet deep
- ◆ Horizontal run of approx. 6 feet
- ◆ Not passable at observed flow
- ◆ Potentially passable at high flows
